Bad controller communication with the PC

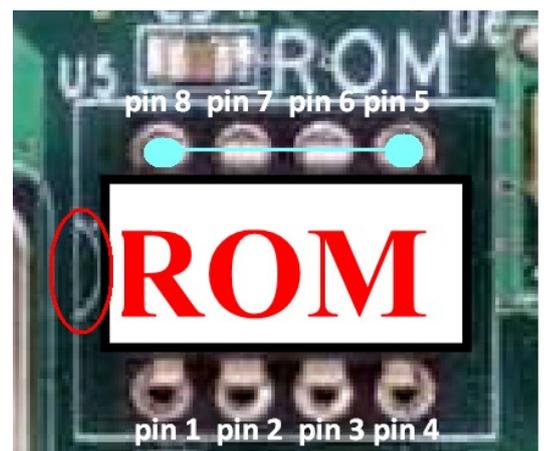
A controller which communicated perfectly, does not communicate with the software sometimes or for a long period, i.e. on the Real time event window there are messages like "some commands returned error 263 Timeout", or no events are displayed. Pressing on the Reset button of the controller does not give any event on the software screen but doors are still opening with codes and tags means that the controller still work as stand alone mode.

If the Green communication LED is constantly ON:

If the Reset LED blinks:

→ Disconnect the controller from its communication bus.

If the LED is still ON, remove the communication component (the one marked 'Max3085').

If the LED switches OFF, replace the component as it burned.

- Power off the controller
- Remove the ROM
- If there are Kit Com2 components remove them
- Power up and try to read the Boot version with the Flash2000 software.

If the Led does not blink after 2-3 minutes, insert the ROM and try to read the Boot again.

If the communication is OK, flash the controller and initialize it with the software.

If the Led still blinks after 2-3 minutes, replace the ROM.

If the Led still blinks after 2-3 minutes, try to clear the RAM:

- Power off the controller
- Remove the Lithium jumper (JP1)
- On the ROM, shortcut pin 5 with pin 8 together during 5 sec
- Set the JP1 back with the Power
- Check if the communication is restored

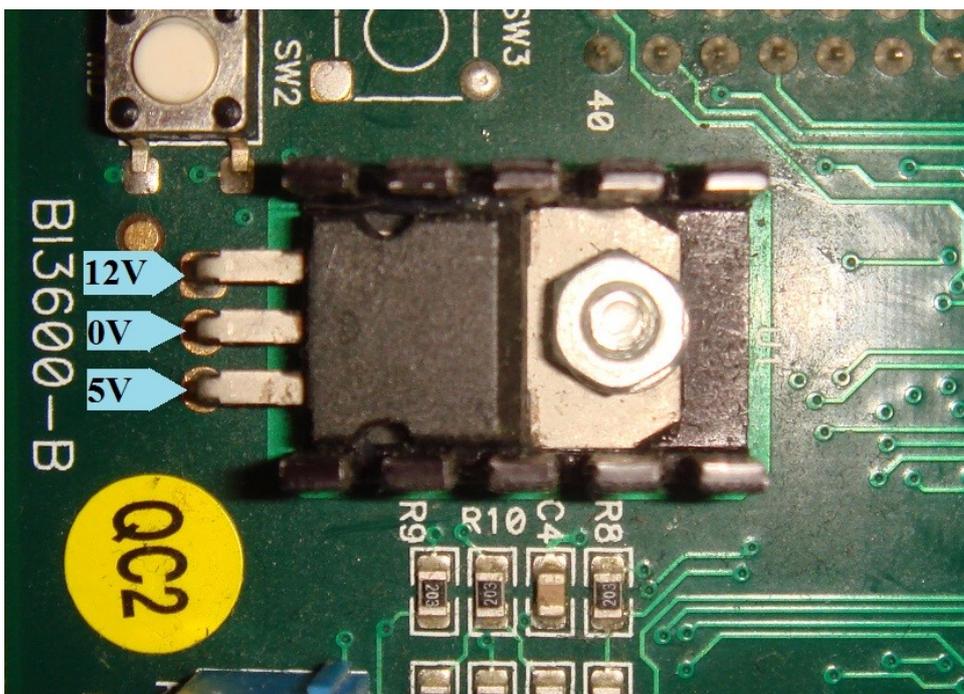
If the controller communicates via TCP module:

→ When the board is powered and connected to the 100Mb Ethernet switch, measure the voltage at the regulator located on the board and check that the voltages are close to the following. If not, the board is faulty.

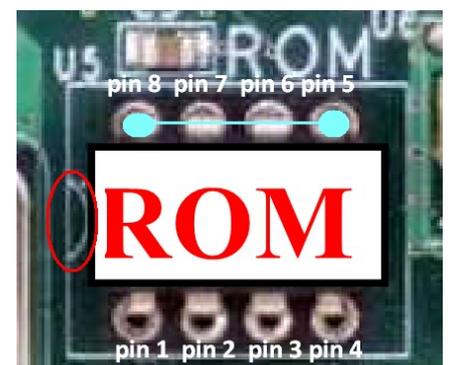
If the Green communication LED is constantly ON:

If the Reset LED blinks sometimes:

- Power off the controller
- Remove the ROM
- If there are Kit Com2 components remove them
- Power up and try to read the Boot version with the Flash2000 software.

If the Led does not blink after 2-3 minutes, insert the ROM and try to read the Boot again. If the communication is OK, flash the controller and initialize it with the software. If the Led still blinks after 2-3 minutes, replace the ROM.

If the Led still blinks after 2-3 minutes, try to clear the RAM:

- Power off the controller
- Remove the Lithium jumper (JP1)
- On the ROM, shortcut pin 5 with pin 8 together during 5 sec
- Set the JP1 back with the Power
- Check if the communication is restored

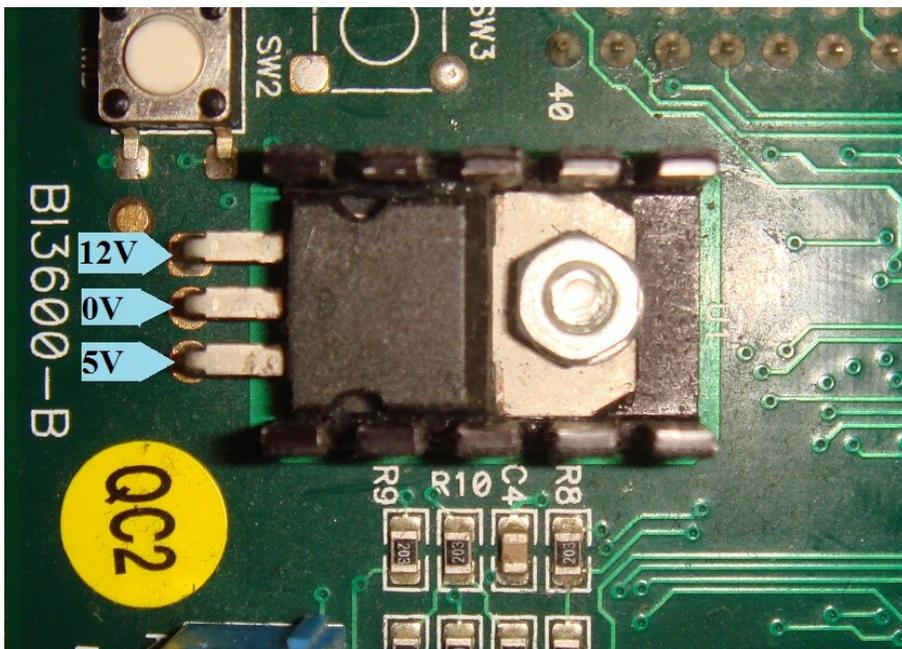
If the controller communicates via TCP module:

→ When the board is powered and connected to the 100Mb Ethernet switch,

measure the voltage at the regulator located on the board and check that the voltages are close to the following. If not, the board is faulty.
